FROM: Iowa FACE Case No. 2010 IA 017 Report date: 10 October 2012

SUBJECT: Fatal burn injury while bulldozing and burning brush

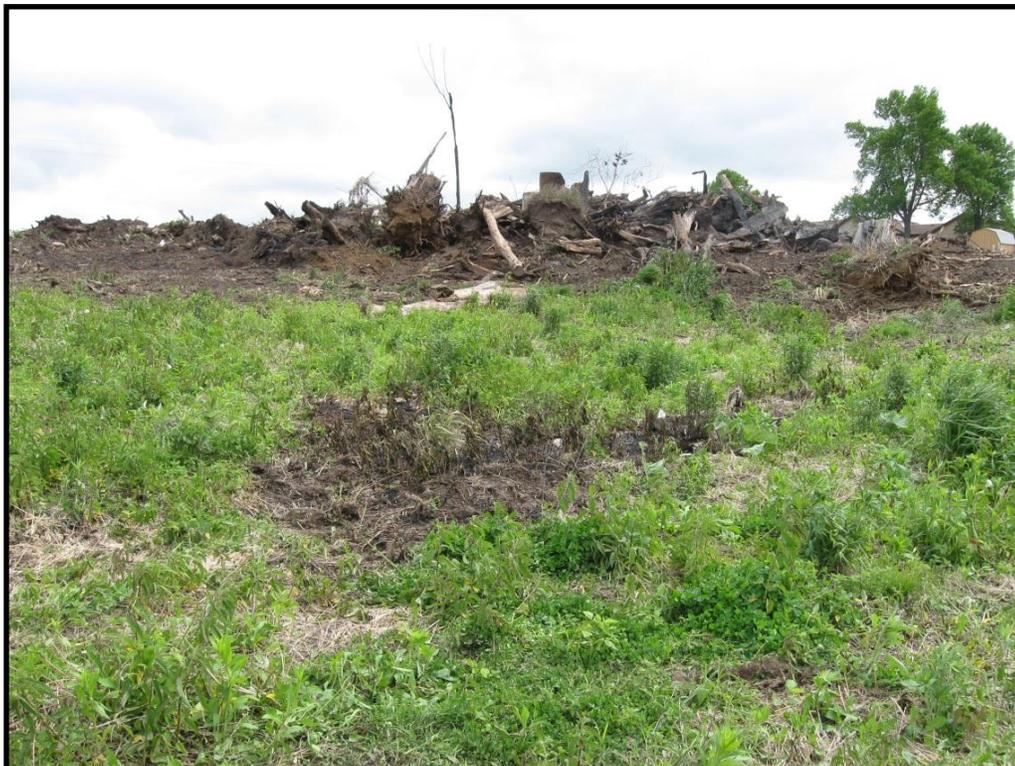
Exhibit 1: Burn pile and burn area on ground where bulldozer is believed to have caught fire

At approximately 1730, the bulldozer caught fire roughly 20 yards southwest of the burn pile (based on subsequent examination of the burn area on the ground, Exhibit 1) in what the operator described as a fireball. Although the operator was severely burned, he managed to put the bulldozer in reverse, jump from the bulldozer, and make his way to his truck parked near the field entrance.

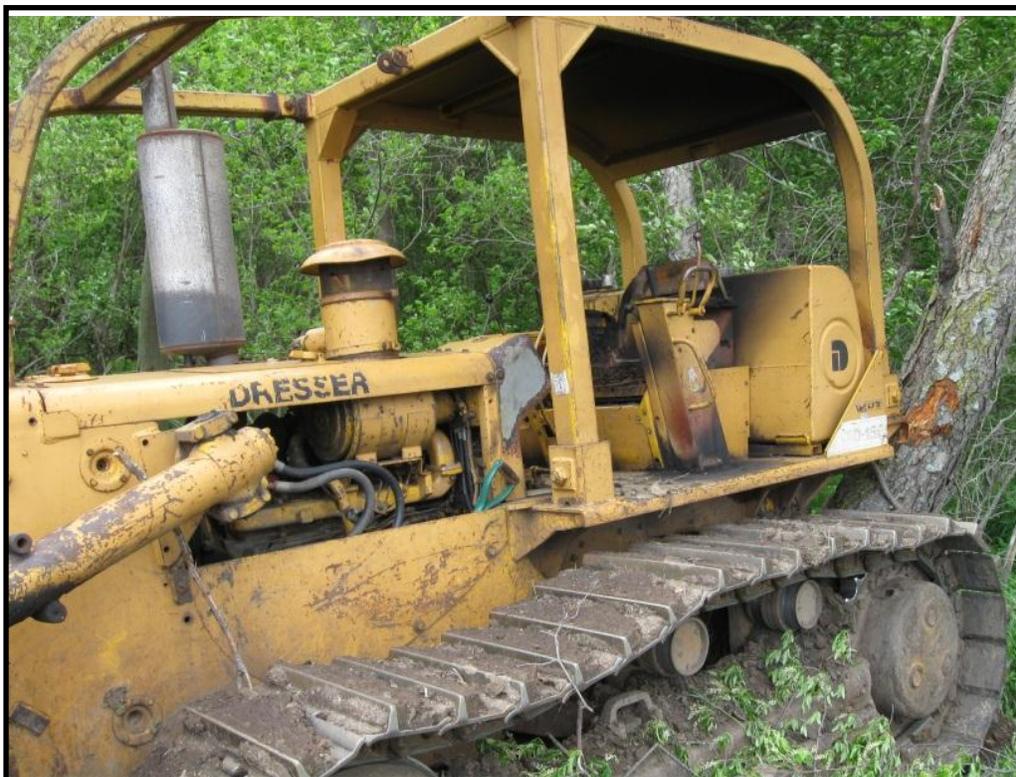
Exhibit 2: Location where bulldozer came to rest

Investigation of the site showed that the bulldozer had traveled southwest in reverse, one-quarter to one-third mile until it ran into some trees (Exhibit 2). It remained in that position with the engine still running,

until the property owner's son went to the site after his father and the victim departed for the hospital. It was estimated the bulldozer had continued to run for at least 30 minutes after the fire started.

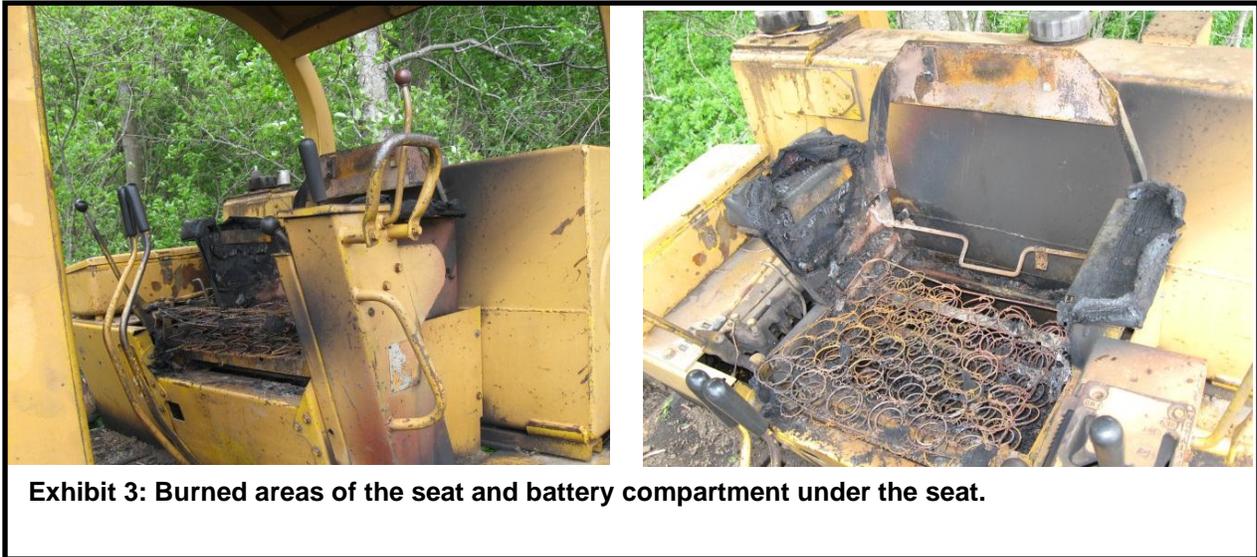
The day after the incident, the Sheriff's office investigated and found that the seat and battery compartment under the seat were severely burned (Exhibit 3). There was a slight burn on the console, but no other burned areas on the bulldozer. When the bulldozer was turned on, there was no evidence of any hydraulic leaks running under the seat console.

The exact cause of the fire has not been determined, and it is not known if the fire started on the bulldozer or the driver. However, evidence suggests that the victim somehow may have gotten an accelerant or burn source on his clothing, which is consistent with the severity of the burns and the location primarily on the upper body. A nurse at the first hospital reported the victim's clothing smelled like diesel or gasoline. Because the burns were primarily on the upper body, it is presumed that the fire did not start in the under-battery compartment. Since the damage to the bulldozer was concentrated on the seat, with non-concurrent burns to the victim's buttocks and lower legs, it is most likely that the burns to the seat compartment occurred after the victim exited the bulldozer. Since the bulldozer continued to operate for at least 30 minutes after the fire started, the fuel source is not likely to be a fuel or fluid leak, which would have been exhausted from the fire.

Machinery should be in good condition to ensure safe operation. Check for hydraulic leaks at fittings and by looking for drips onto cardboard or other surfaces placed below the machine prior to using it in the field. Special attention should be paid to fuel lines and other sources of flammable liquids, especially if the machinery will be near open flames.
